Re: Facility BUILD; Taos Senior Center; SIC 1542; NPDES Compliance Evaluation Inspection; NPDES Permit No. NMR1001HE; September 20, 2018

Taos Senior Center Construction General Permit (CGP) Compliance Evaluation Inspection (CEI)

September 20, 2018

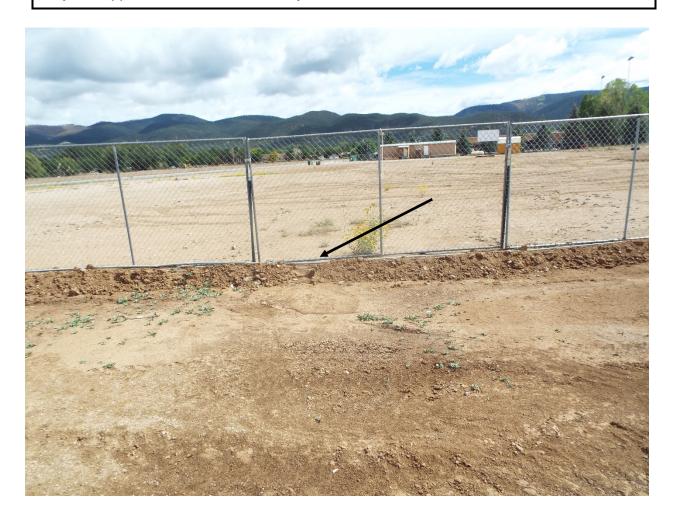
Subject: Appearance of run-on from adjacent vacant lot with break in berm.

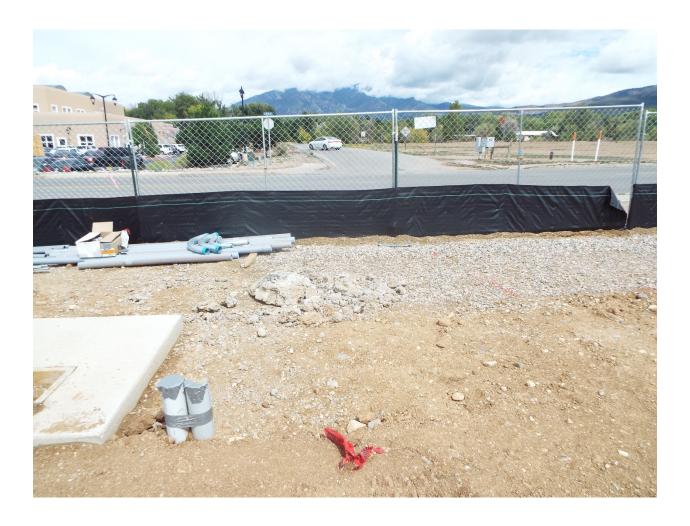
The concrete lined pit needs some maintenance as it is nearing capacity, along with solid pieces of concrete as shown in the photo #2.

Subject: Hardened Cement on the ground

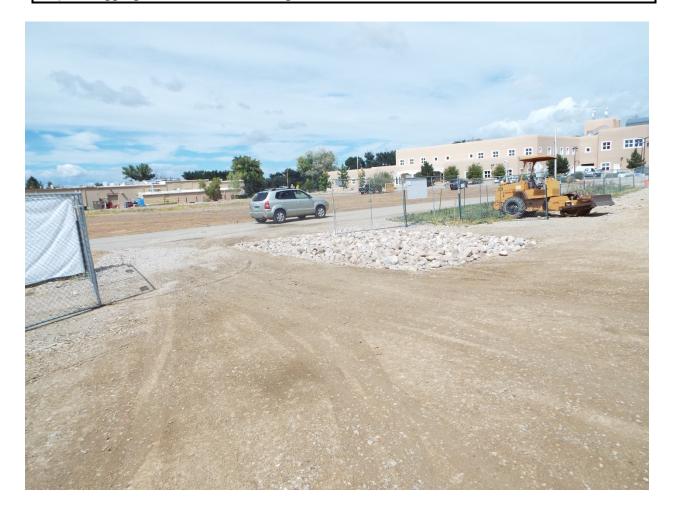
The site has an aggregate stone exit, but it is not being used by construction traffic.

Photographer: Daniel Valenta	Date: September 20, 2018	Time: 1302 Hours						
City/County: Town of Taos / Taos	State: New Mexico							
Location: Taos Senior Center / Albright & Lovato Pl								
Subject: Aggregate entrance, not being used.

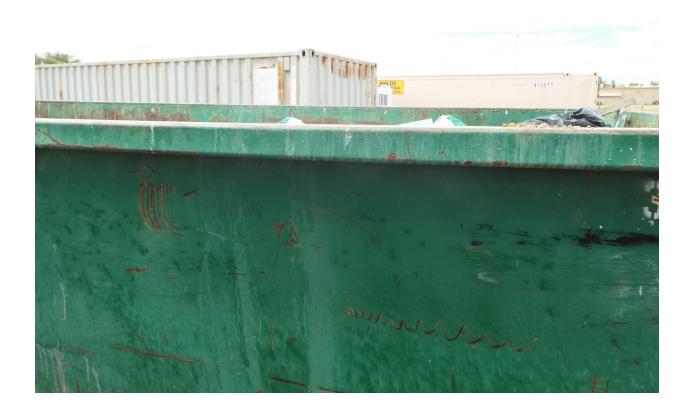
The operator has a trash bin provided for construction; however; they need to be maintained so that they can be closed at the end of each business day.

Photographer: Daniel Valenta	Date: September 20, 2018	Time: 1304 Hours						
City/County: Town of Taos / Taos	State: New Mexico							
Location: Taos Senior Center / Albright & Lovato Pl								
Subject: Uncovered bin.

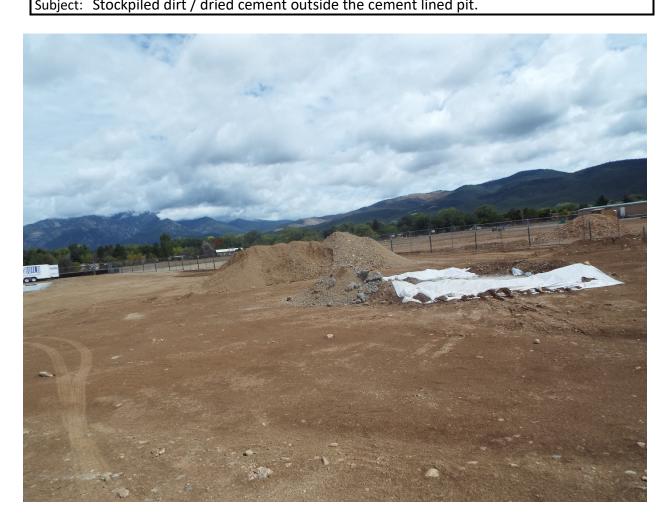
There is a stockpile of dirt located within the fence line of the project site. The foreman stated he believes it has been located there longer than 14 days but was unsure.

Photographer: Daniel Valenta	Date: September 20, 2018	Time: 1256 Hours						
City/County: Town of Taos / Taos	State: New Mexico							
Location: Taos Senior Center / Albright & Lovato Pl								
Subject: Stockniled dirt / dried cement outside the cement lined nit
